Manhole Inspection Summary

Manhole # S61U__004MH

Insp Date: **4/29/08 1:40 PM**

Location Address: **1701 Poncabird Pass**

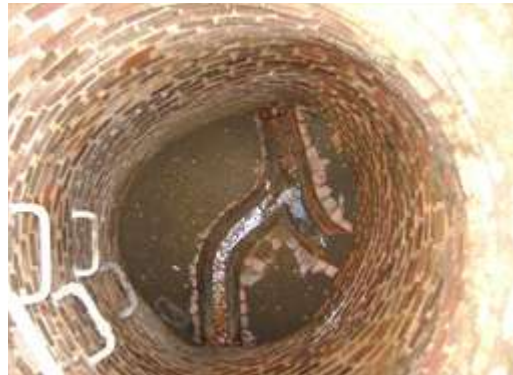
Top View

Condition: ☐ Sound ☐ Cracked ☐ Root Intrusion ☐ Deteriorated ☐ Leaks ☒ **Debris**

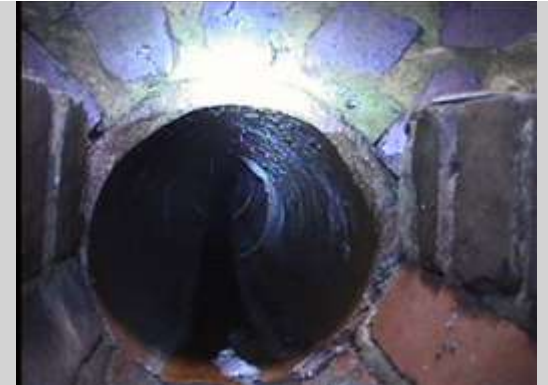
12 O'Clock Outflow

8 in. Circular Gravity Sewer
Pipe Out @ 12 O'Clock

Pipe Height: **8.4** (in.) Rod and Bar (Angled)
Pipe Material: **Clay** ☐ Pipe Lined
Invert Depth: **10.75** (ft.) Flow Characteristics: **Fast**
Deposits: ☒ None ☐ Mud ☐ Sludge ☐ Debris ☐ Grease
Silt Depth: (in.) Deposits Extent:
Infiltration: **None** Pipe Seal Cond: **Sound**

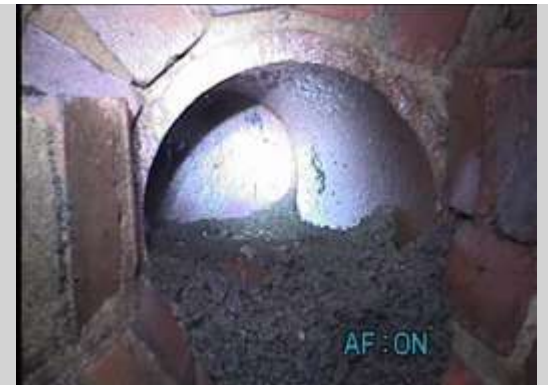
3 O'Clock Inflow

8 in. Circular Gravity Sewer
Pipe In @ 3 O'Clock

Pipe Height: **8.4** (in.) Rod and Bar (Angled)
Pipe Material: **Clay** ☐ Pipe Lined
Invert Depth: **10.33** (ft.) Flow Characteristics: **None**
Deposits: ☐ None ☐ Mud ☐ Sludge ☒ **Debris** ☐ Grease
Silt Depth: **2** (in.) Deposits Extent: **Medium**
Infiltration: **None** Pipe Seal Cond: **Sound**

Connects To: **Stub connection / abandoned**

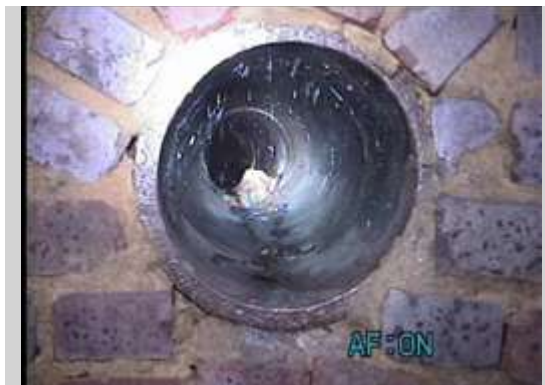
6 O'Clock Inflow

Pipe In @ 6 O'Clock

Pipe Height: **8.4** (in.) Rod and Bar (Angled)

Pipe Material: **Clay** ☐ Pipe Lined

Invert Depth: **7.42** (ft.) Flow Characteristics: **Fast**

Deposits: ☒ None ☐ Mud ☐ Sludge ☐ Debris ☐ Grease

Infiltration: **None** Pipe Seal Cond: **Sound**

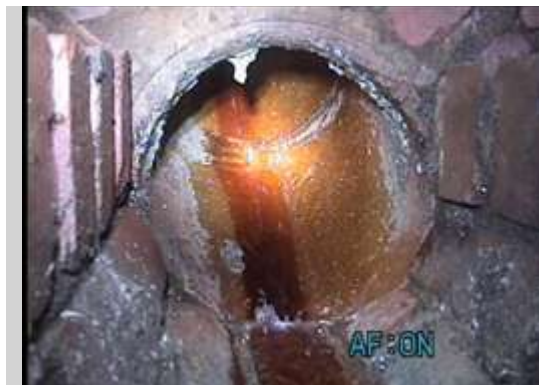
Drop In @ 6 O'Clock

Drop: **Outside** Rod and Bar

Angled: **Yes** Reading: **9.50** (ft.)

Inv Depth: **10.50** (ft.)

Drop Condition: **Open**
